CARR - 761

1623 WASHINGTON ROAD

FIELD SHEET--HISTORIC RESOURCES SURVEY

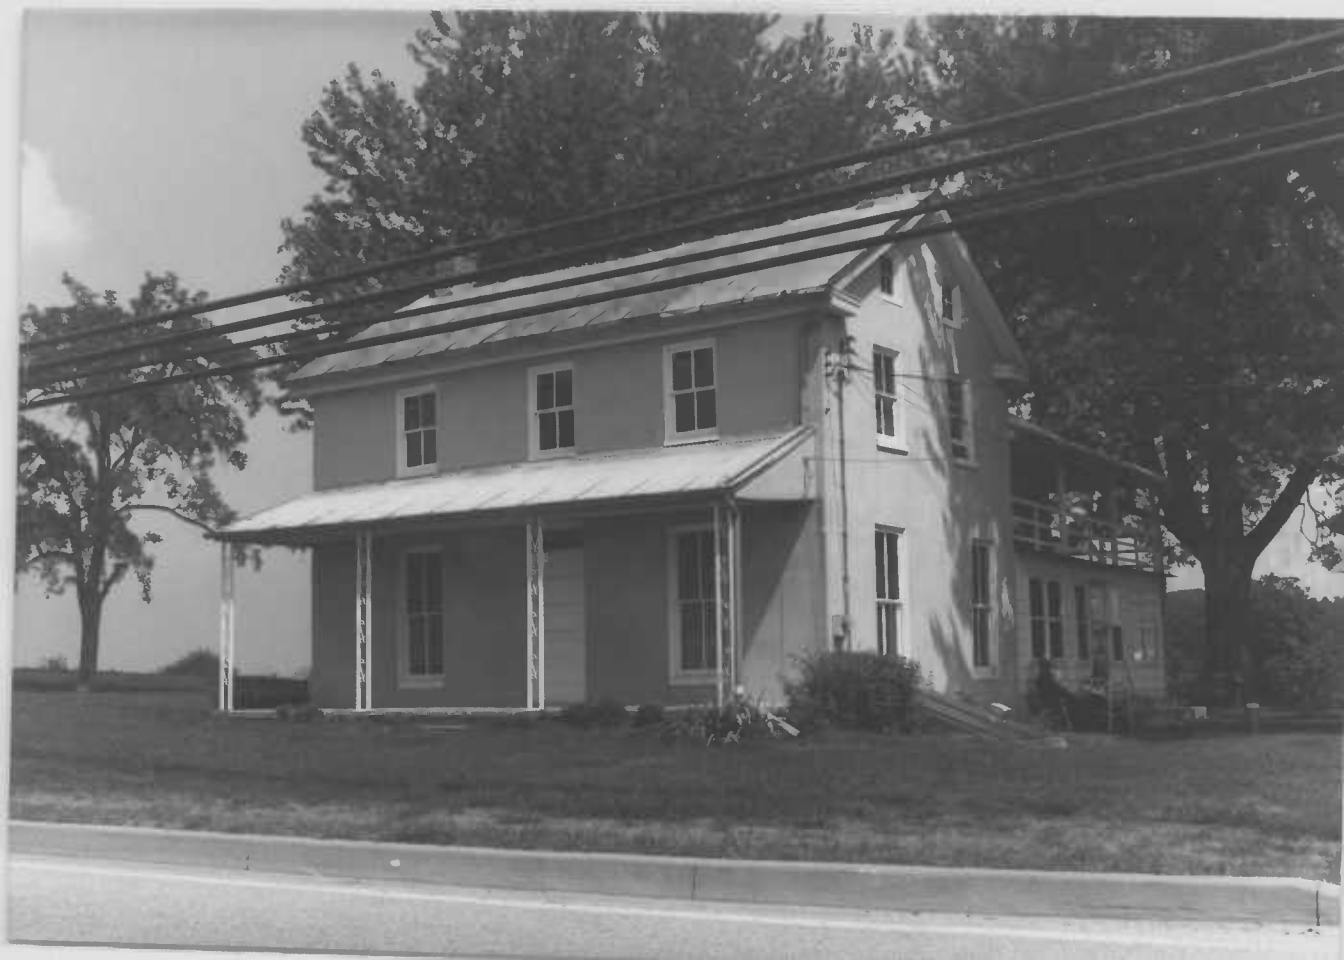
1. CARR-761 1623 WASHINGTON ROAD
2. Carroll County, Maryland
3. Joe Getty
4. August 1983
5. Md. Historical Trust, Annapolis, Md.
6. South and west elevations
(camera facing northeast)
7. 1/1
